Flexco's quick solution for belt damage

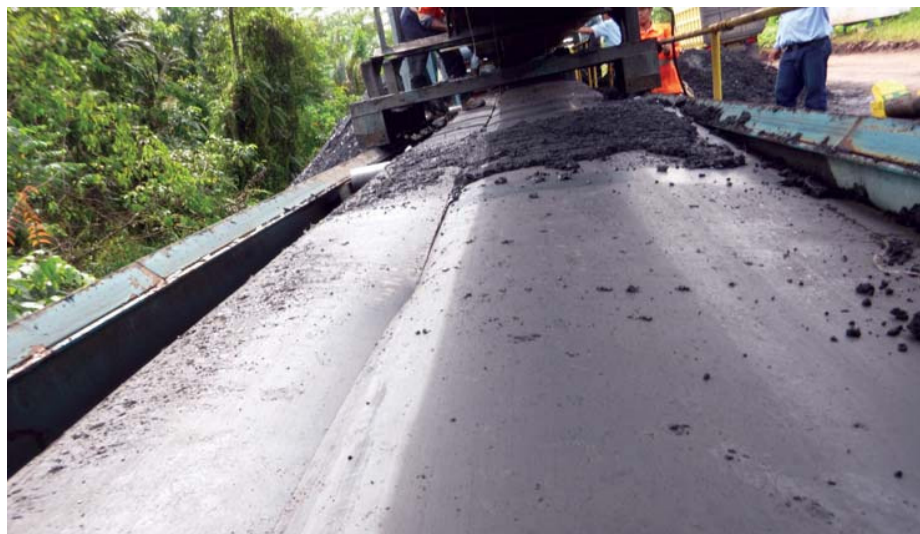
Flexco was able to repair a conveyor tear (above) at Adimitra Baratama Coal's operations using Flexco Bolt Solid Plate 190 fasteners (below).

"They offered their advice and recommendations, and I discussed it with my team," Wandy Gunawan said. "Their timely action and product demonstrations were very helpful." The unscheduled downtime was already costing valuable production time and it was decided to use Flexco Bolt Solid Plate 190 fasteners to repair the 1000 metre rip. This fastening system provides a strong, sift-free splice with superior holding ability for use in tough material handling applications. It also allows for quick and easy onsite installation.

Dany Koesoema says the design and plate compression on both the top and bottom sides of the belt is key to the strength. High tensile strength bolts compress top and bottom plates to distribute splice tension across the entire width of the fastener plate.

Specially-formed teeth penetrate deep into the belt carcass for added strength without damaging the carcass fibres. Ideal for use in tough, abrasive applications like coal, the Bolt Solid Plate Fastening System can be easily installed with portable hand tools or power tools. Exclusive piloted bolts feature tapered tips that cradle the nuts securely in place, reducing installation time.
